Success Stories in Sustainable Agriculture:

In Hamilton and Story County, researchers are working with landowners to establish and test saturated buffers to treat farm runoff.

SATURATED BUFFERS

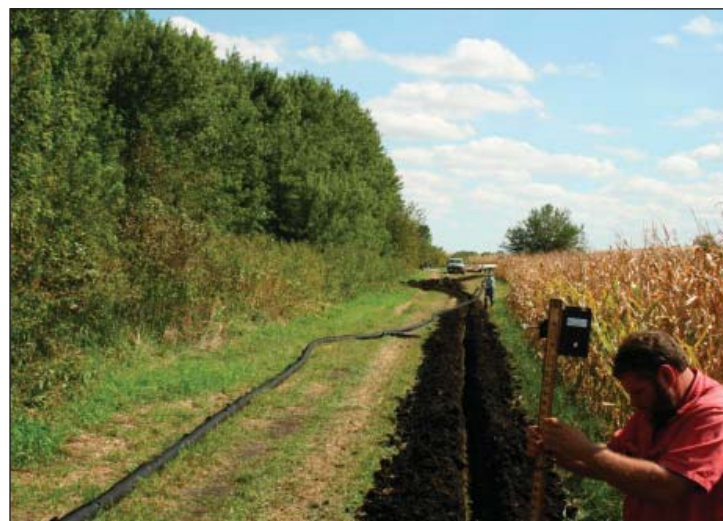
A new line redirects tile water into the nearby riparian buffer along Bear Creek on the Hansen farm. Credit: Kent Heikens

In 2010, the riparian buffer research team received a Leopold Center grant to study the impact on nitrate removal in a riparian buffer in which part of the tile drainage water is redirected to flow through the buffer. They called this a saturated buffer, and the practice is intended to make further use of the buffer’s ability to improve water quality. They created a saturated buffer at an existing Bear Creek buffer. A second saturated buffer also was installed on Maass’ land. The three-year study produced surprising results.

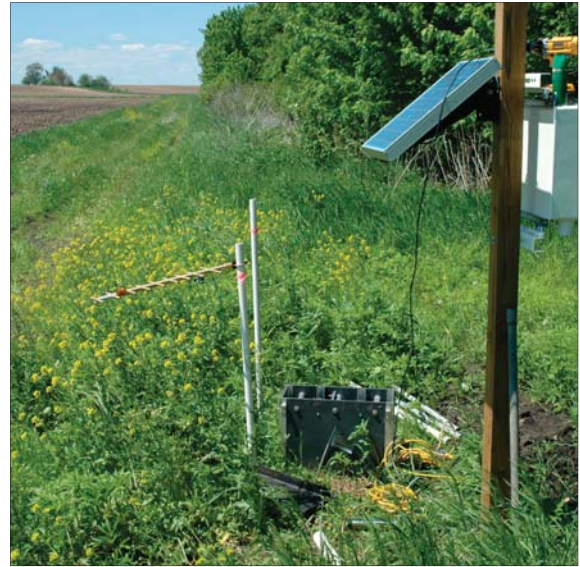
This is where tile water is redistributed. Data is uploaded remotely, powered by solar cells. Credit: Kent Heikens
